UNITED STATES ENVIRONMENTAL PROTECTION AGENCY

Re: Notice of Violation Compliance Evaluation Inspection ILR 000 009 795

On June 11, 2015 a representative of the U.S. Environmental Protection Agency inspected the Northstar Aerospace (Chicago), Inc. (Northstar) facility located in Bedford Park, Illinois. As a "large quantity generator" of hazardous waste, Northstar is subject to the Resource Conservation and Recovery Act, 42 U.S.C. § 6901 et seq. (RCRA). The purpose of the inspection was to evaluate Northstar's compliance with certain provisions of RCRA and its implementing regulations related to the generation, treatment and storage of hazardous waste. A copy of the inspection report is enclosed for your reference.

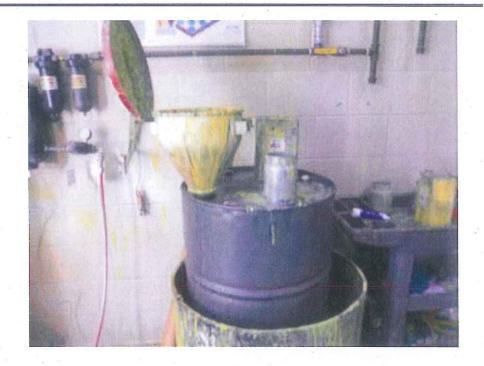
Paint Booth Satellite Accumulation Area (SAA) 55-gallon container. Container was open. No words identifying the contents of the container were located on the container.

At the time of the inspection, Northstar was storing one open 55-gallon container of hazardous waste in one satellite accumulation area (SAA), when waste was not being added to or removed from the container. The container also did not contain the words, "Hazardous Waste," or words that identified the contents of the container. *See*, Inspection Report, page 2, Site Inspection, paragraph 1.

Mr. Kolb escorted me on the physical site inspection, which began in the Paint Booth Area. One 55-gallon container storing hazardous waste was being stored as a satellite accumulation area (SAA) container. The container was not closed and did not have words identifying the contents of the container. *See*, photographs 1 and 2.

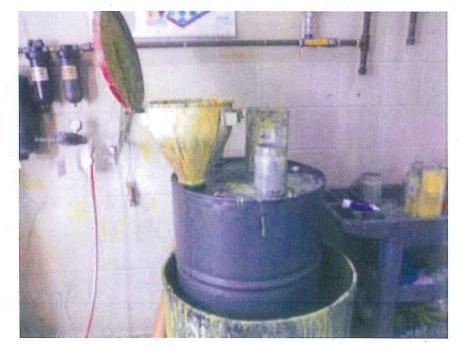
Disk Number 1
Photo Number 2

Paint Booth Satellite Accumulation Area (SAA) 55-gallon container. Container was open. No words identifying the contents of the container were located on the container.

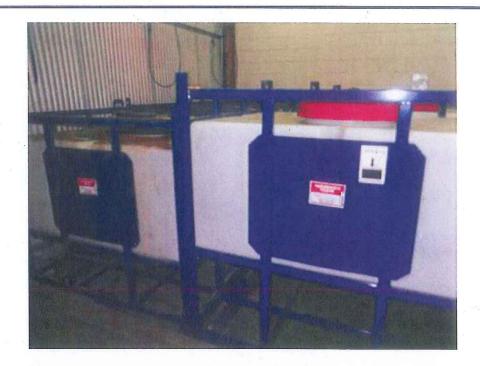
Hazardous Waste Storage Area. Two totes, storing hazardous waste, did not contain dates of accumulation on the containers.

At the time of the inspection, Northstar was storing two totes of hazardous waste, located in the hazardous waste storage area, without dates of accumulation marked on the containers. *See*, Inspection Report, page 2, Site Inspection, paragraph 2.

We then proceeded to the hazardous waste storage area. Two totes were storing hazardous waste located in this area; however, the containers were not marked with dates of accumulation. Several 55-gallon containers of hazardous waste were also stored in this area; however the labels

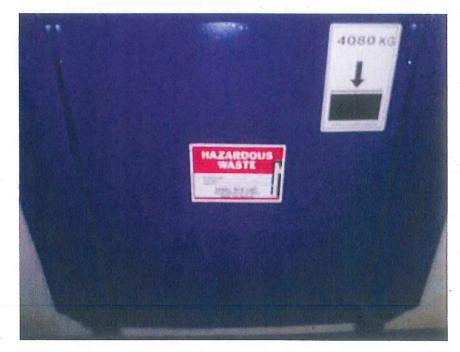
Hazardous Waste Storage Area. View of hazardous waste label without a date of accumulation. Two totes of hazardous waste were being stored without dates.

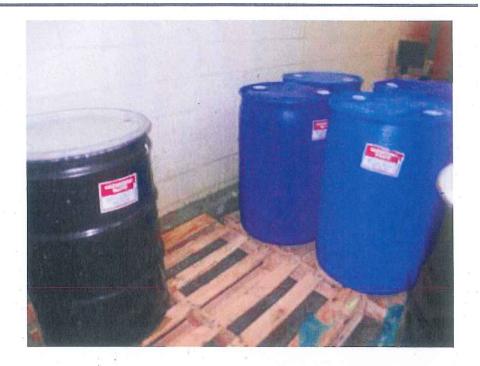
Hazardous Waste Storage Area. 55-gallon containers were being stored with hazardous waste labels. However, the labels were turned in and difficult to view. It was also difficult to read the dates of accumulation.

Northstar was also storing several 55-gallon containers of hazardous waste with labels that were not visible for inspection on each container. *See*, Inspection Report, page 2, Site Inspection, paragraph 2.

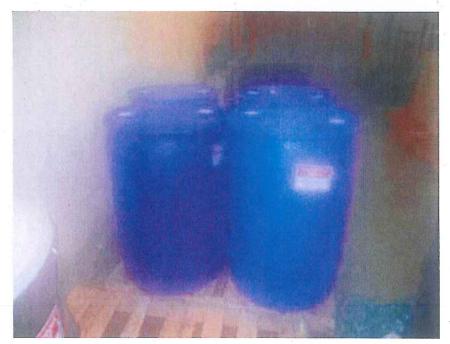
Hazardous Waste Storage Area. 55-gallon containers were being stored with hazardous waste labels. However, the labels were turned in and difficult to view. It was also difficult to read the dates of accumulation.

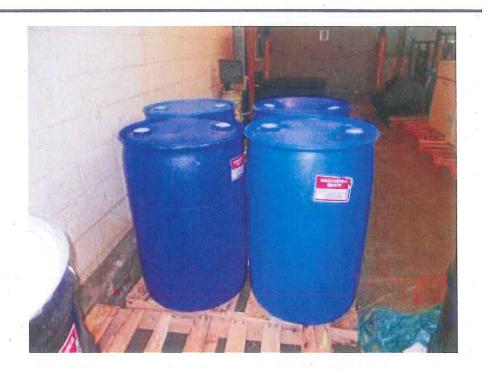
Hazardous Waste Storage Area. 55-gallon containers were being stored with hazardous waste labels. However, the labels were turned in and difficult to view. It was also difficult to read the dates of accumulation.

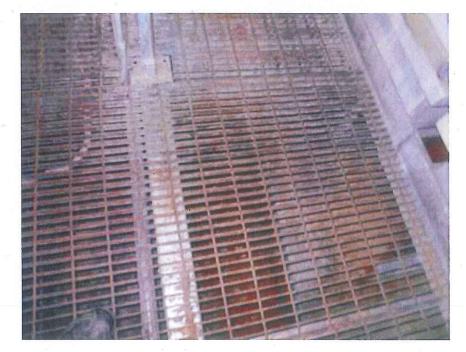
Photo Number 8

Plating Line Trench. The trench collects rinse waters and drippage from the plating line. Then the material travels to the waste water treatment unit. (black oxide)

Mr. Kolb introduced me to Ms. Yvonne Reno, Materials and Process Engineer, after inspecting the hazardous waste storage area. Ms. Reno showed me the plating lines. Northstar operates several plating lines, including a black oxide line and an Allodine Line. Cyanide is used in one of the lines. The lines are situated on a platform. A trench is located underneath the grating. Rinse waters and drippings are collected in the trenches and then flushed to the WWTU. See, photographs 8 and 9.

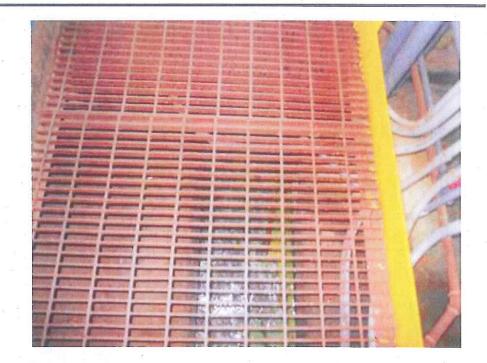
Allodine Line. Waste waters are collected into trench and then flushed to the waste water treatment unit.

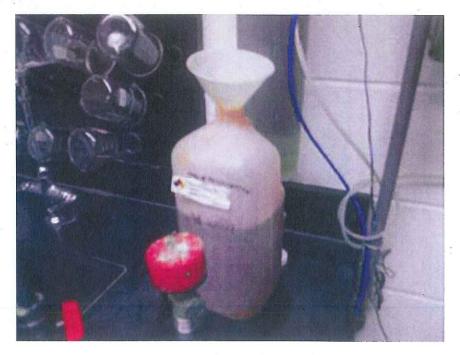
Laboratory SAA container. The container was storing non-cyanide hazardous waste and was open. The hazardous waste is placed into a tote for storage in the hazardous waste storage area once the container is full.

In addition, Northstar was storing one open container of hazardous waste in an SAA area in the laboratory when waste was not being added to or removed from the container. See, Inspection Report, page 3, Site Inspection, paragraph 4.

Ms. Reno introduced me to Mr. Richard Musil, Environmental Technical Specialist, who showed me the laboratory. One SAA container was located near the sink. The container was storing non-cyanide hazardous waste and was open at the time of the inspection. Once the container is full, the hazardous waste is placed into a tote for storage in the hazardous waste storage area. A separate SAA container was storing cyanide hazardous waste and was located in a separate area in the laboratory. *See*, photographs 10 and 11.

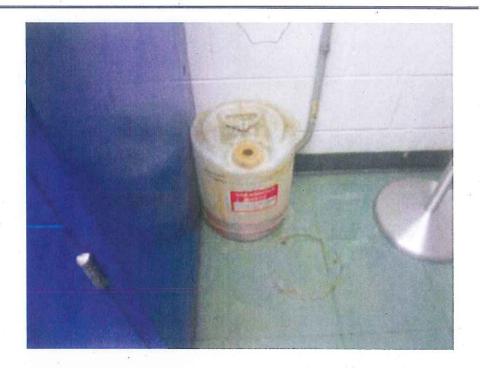
Laboratory SAA container. Cyanide hazardous waste storage.

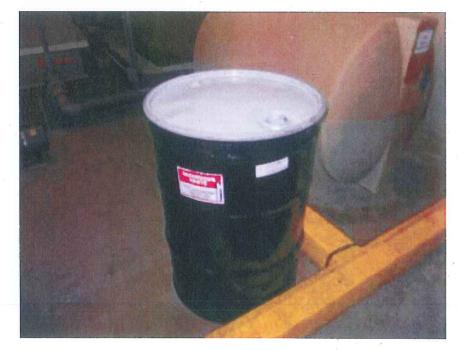
Waste water treatment unit (WWTU) area. An SAA 55-gallon container was storing filters collected from the WWTU.

Mr. Musil escorted me to the WWTU. A 55-gallon container of filters, collected from the WWTU, was located in this area. The hazardous waste filter cake, F006, was being collected in a cubic yard fiber box from the filter press. The container was open because the operator had just dropped hazardous waste into the container. *See*, photographs 12 through 14.

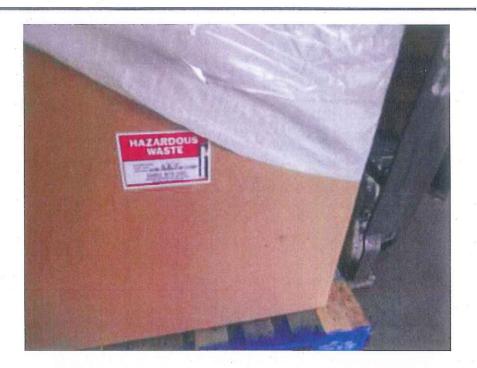
WWTU area. Hazardous waste filter cake was being collected in a fiber box from the filter press. F006 hazardous waste.

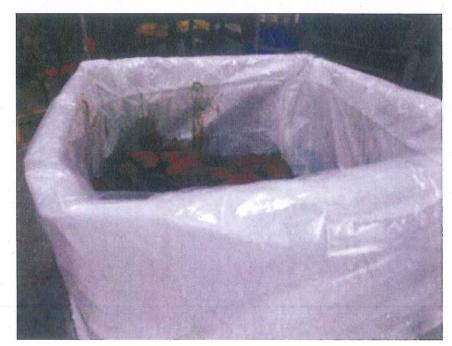
WWTU area. Hazardous waste filter cake was being collected in a fiber box from the filter press. F006 hazardous waste. The container was opened because the operator had just dropped hazardous waste into the container.
